**VIBRATION TESTING OF THE TE-M-604-4 IUE
ROCKET MOTOR (THIOKOL P/N E 28639-03)**

VON KÁRMÁN GAS DYNAMICS FACILITY
ARNOLD ENGINEERING DEVELOPMENT CENTER
AIR FORCE SYSTEMS COMMAND
ARNOLD AIR FORCE STATION, TENNESSEE 37389

December 1976

Final Report for Period 3 - 28 May 1976

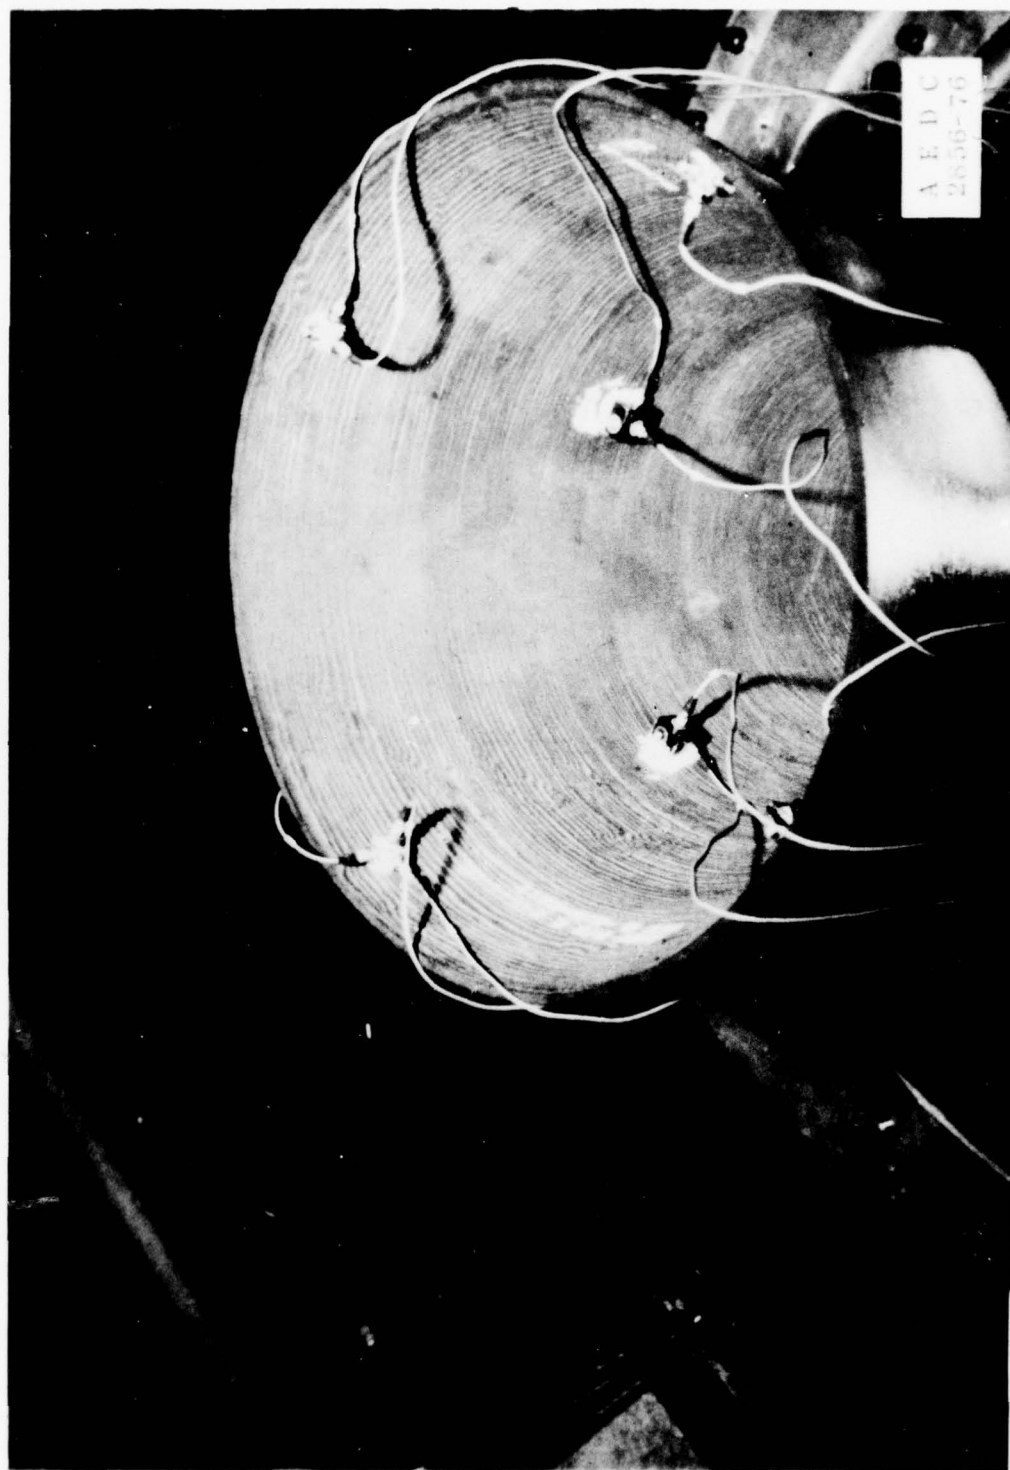
Figure 11. X-axis motor installation photographs.

The IUE motor (S/N 0002) was installed in the lateral axis vibration fixture in preparation for X-axis testing. Installation photographs, including accelerometers, are shown in Fig. 11. The X-axis 0.5-g sine survey was then conducted. The X-Y plots of all acceleration signals recorded during this survey are shown in Fig. 12. All X-Y plots were made from the magnetic tape recording following completion of the entire test program, except for the closed loop control plot and the control average online plot. All data channels were displayed on the recording oscillograph following the individual vibration tests.

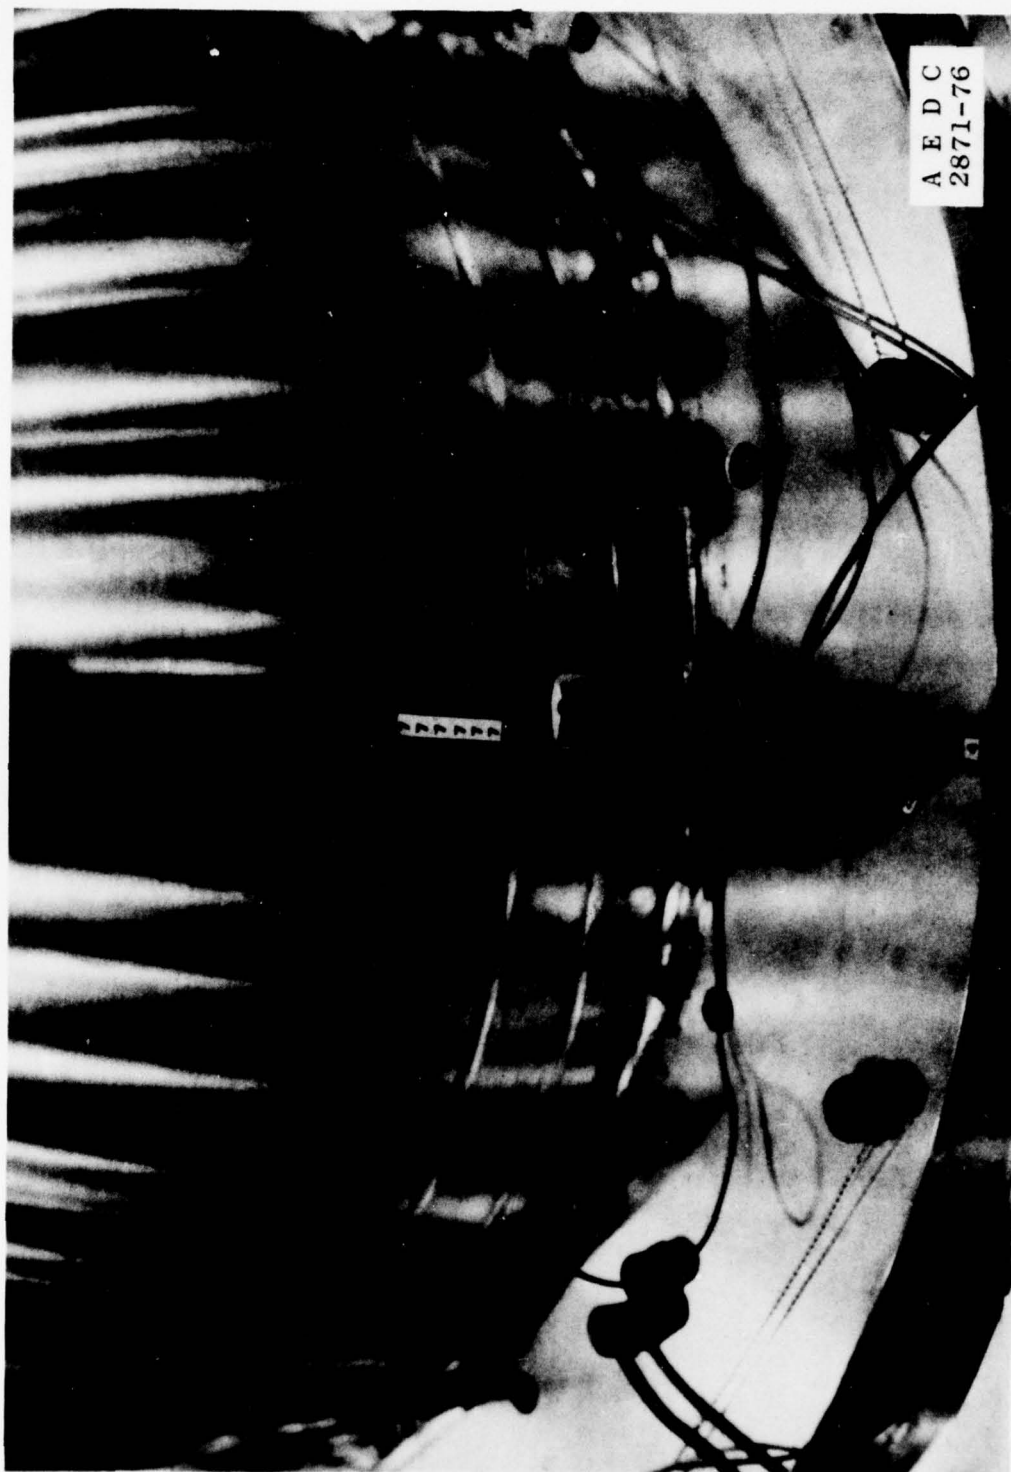
Figure 16. Y-axis motor installation photographs.

The Y-axis test program was conducted in the same manner as the X-axis test. Installation photographs for the Y-axis are shown in Fig. 16. The 0.5-g sine surveys and qualification level sine and random vibration test results are shown in Figs. 17 through 20. No significant acceleration differences were noted with the X-axis test results, as would be expected due to the motor symmetry.

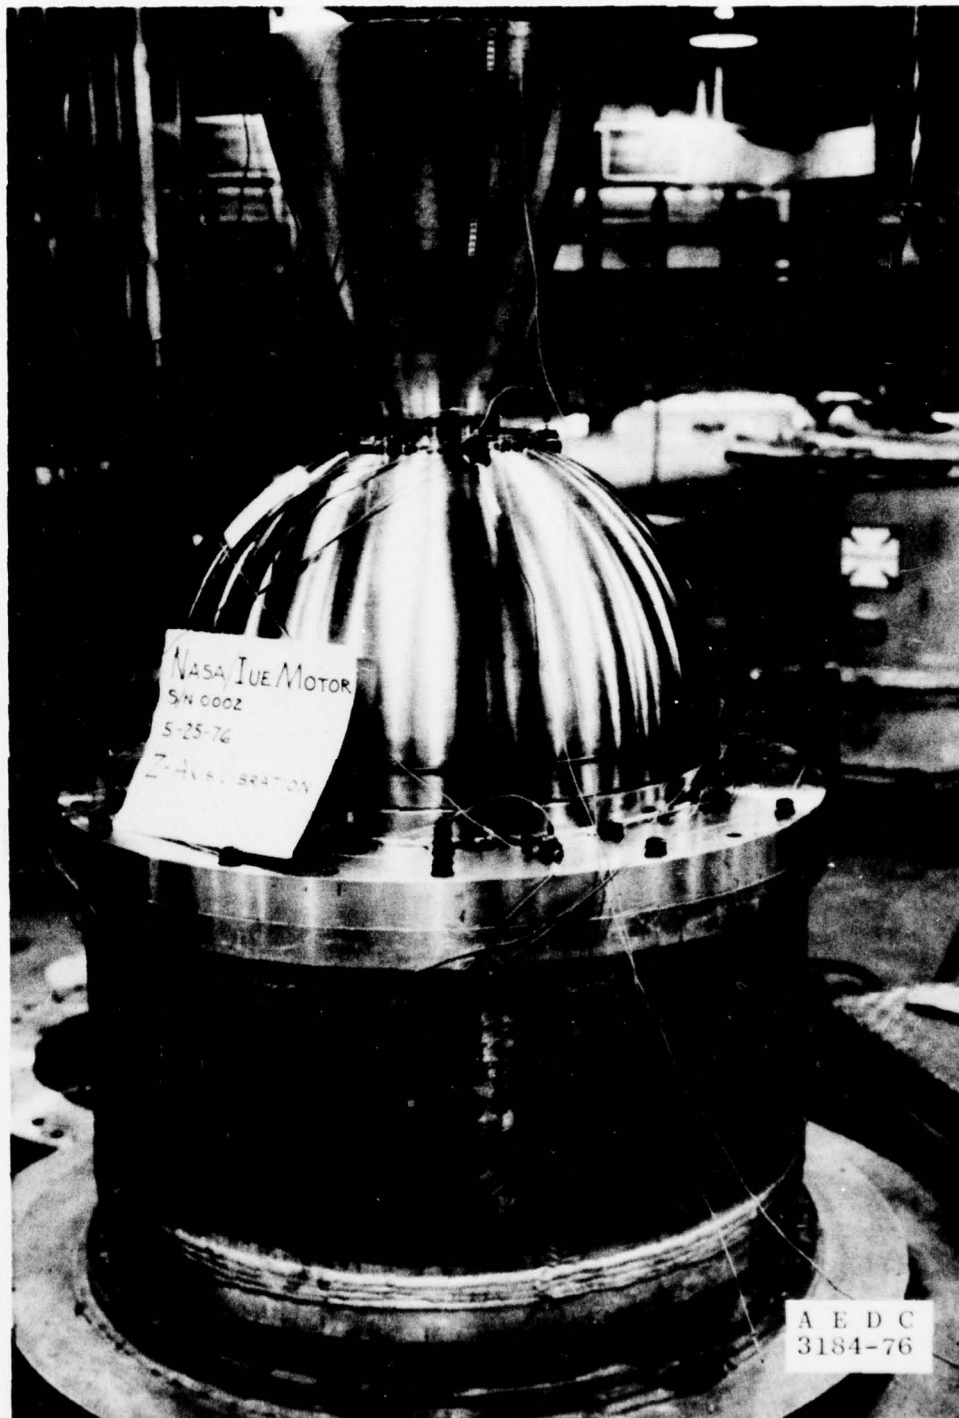
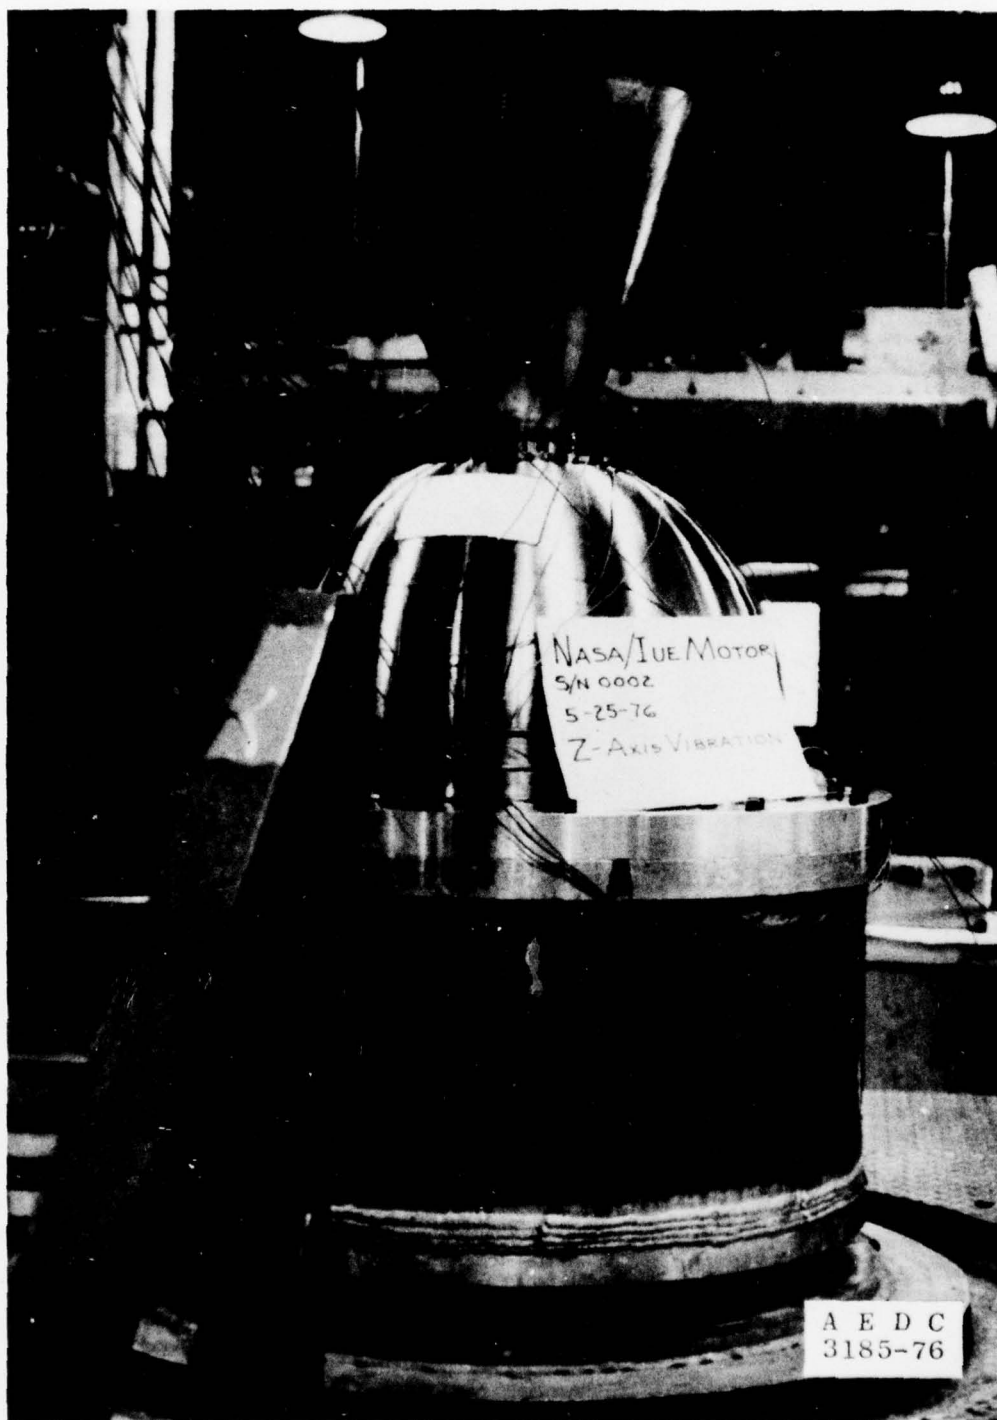
Figure 28. Z-axis installation photographs.

The qualification testing of the IUE motor in the thrust (Z) axis was similar to the lateral axis program, a low level sine survey prior to and following qualification level sine and random testing. The photographs of the motor installed in the thrust axis fixture are shown in Fig. 28. The results of the first 0.5-g sine survey are shown in Fig. 29. A nozzle resonance mechanical transmissibility factor (Q) of approximately 40 was noted at the 328-Hz resonant point. Due to this higher than anticipated Q value, a second sine survey was conducted at a 1.0-g input to verify the linearity of the magnification. The results of this survey are shown in Fig. 30. A Q value of 44 at
